**Flood Control Project Maintenance
Levee Inspections**

Fall 2018 Levee Maintenance Deficiency Summary Report

Reclamation District No. 0827 Elkhorn

Levee Inspection Report By Mile - Fall 2018

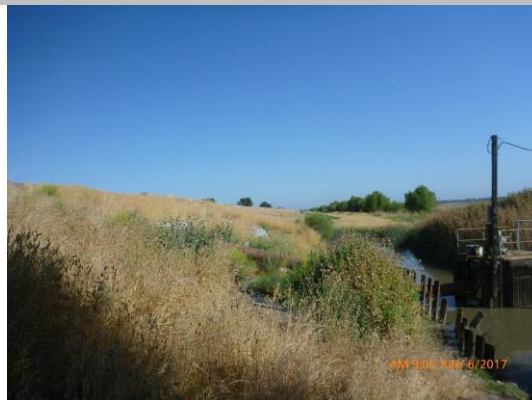
Photo 4 of 6 : LEVAL_FA_2018_199_1231.jpg

LM Start	2.72	Rating **	M	Issue No.	13 (cont)
LM End	2.73	Issue Type +	Ma	Location *	
Category	Supplemental			GPS Latitude/Longitude	
				Start	End
Item	2017 Storm Damage			38.642139°	38.642028°
				-121.620750°	-121.620667°
DWR ID	DWR_RD0827_02_f_2017_13				
Comment Code					
Inspector Comment					
Levee Evaluation Comments					
Description:					
Site ID No:199					
Site Designation:RD 827-01					
Repair Type: Erosion					
Rating:Area of Concern					
Field Date:6/6/2017					
Notes: landside. Visqueen has dried up and is no longer protecting the slope.

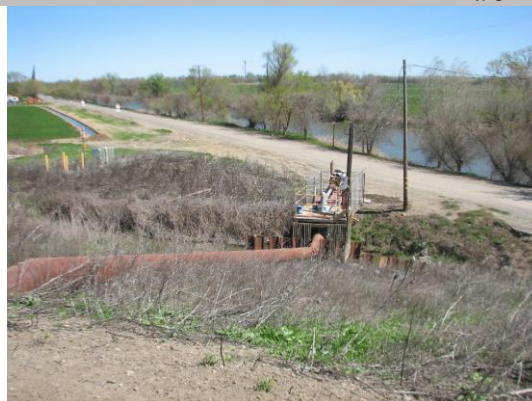
Photo 2 of 3 : UCIP_FA_2018_38984_59768.jpg

View of pipe visible on waterward side.

Comment Code						
Inspector Comment						
FS_ID:38984 DS_ID:21151 EP_NO: 3277 Repair Type: Non-Urgent Crossing Status: Found UCIP Comments: Crossing appears to have been removed and replaced under maintenance back in 2008. No permit has been found--need to contact owner to obtain additional information about replacement. Landward slope sloughing--does not appear to be associated with crossing. Landward slope is being monitored by LMA. FIELD_STRUCT_DESC: 18-inch (not 20-inch as noted in desk study) steel drainage pipe through the levee, 4 feet below the crown. Cutoff wall around pipe at center of levee. Siphon breaker on apex of pipe at waterside (LS) shoulder. Pump on pipe structure in drainage ditch at landside (LS) toe. Rock revetment on WS slope. (20-inch drainage pipe authorized under Permit No. 3277, 1960-Reclamation District No. 827; no permit found authorizing the 18-inch pipe) [Additional Reference(s): DWR Levee Logs, 2005] FS Date: 3/18/2014

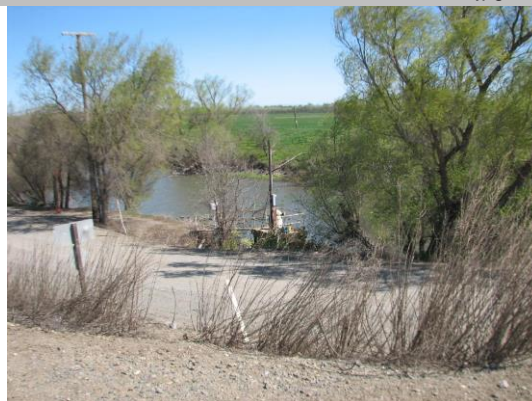
Photo 2 of 3 : UCIP_FA_2018_33032_59777.jpg

Comment Code						
Inspector Comment						
FS_ID:33032 DS_ID:21169 EP_NO: 5611 Repair Type: Non-Urgent Crossing Status: Found UCIP Comments: Crossing appears to have been removed and replaced under maintenance back in 2008. No permit has been found--need to contact owner to obtain additional information about replacement. FIELD_STRUCT_DESC: [RD No. 827 Pumping Plant] 22-inch (not 24-inch as mentioned in desk study) steel drainage pipe through the levee, 8 feet below the crown. Corrugated metal cutoff wall around pipe at center of levee. Siphon breaker on waterside (WS) slope. Flap gate on WS end. Pipe is exposed along WS slope. (portion of pipe was removed and replaced, from landside to waterside shoulder, under Permit No. 5611 (1968)). [Additional Reference(s): DWR Levee Logs, 2005. USACE Sacramento O&M Manual Unit No. 122 Part No. 1, August 1955, (Station 3+75)] FS Date: 3/18/2014

Pump station located on landward side.
